A PAVEMENT RATING SYSTEM FOR HOT-MIX ASPHALT PAVEMENT

A PAVEMENT RATING SYSTEM FOR HOT-MIX ASPHALT PAVEMENTS

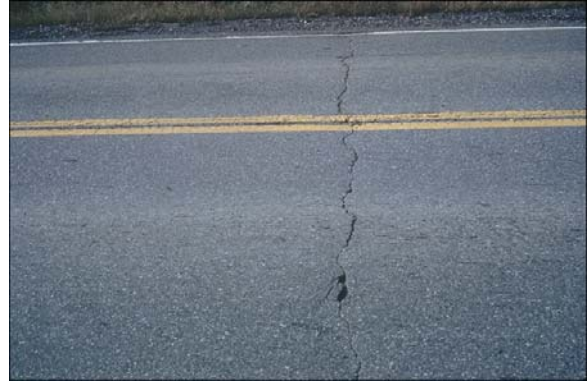
TRANSVERSE CRACK: A crack that follows a course approximately at right angles to the pavement centerline. This frequently is caused by movement in the pavement beneath the HMA layer (reflection cracking). It can also result from stresses induced by low-temperature contraction of the pavement. It may require sealing or filling with asphalt material. At a later date, this may be followed by an overlay (eg. tight blade, paver lay) or mill and fill over the entire surface. *Photo courtesy of the US DOT and National Center for Asphalt Technology (NCAT).*

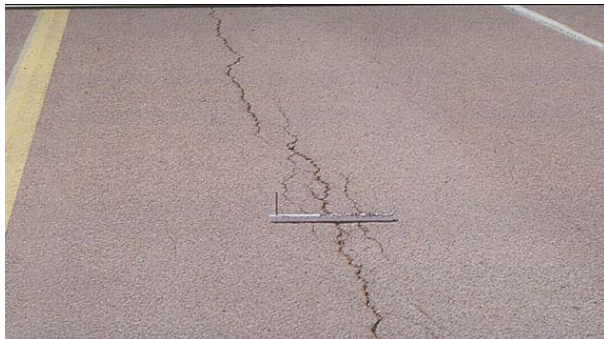
LONGITUDINAL CRACK: A crack that follows a course approximately parallel to the centerline.

This usually results from a weak joint between paving lanes. These cracks can also result from earth movements, particularly on embankments. Two closely-spaced longitudinal cracks in the wheel path usually indicate bending stress induced by rutting. Longitudinal cracks can also occur as a result of movement in the pavement beneath the HMA layer (reflection cracking or stripping). For repair, see "Transverse Crack." *Photo courtesy of the US DOT and NCAT.*

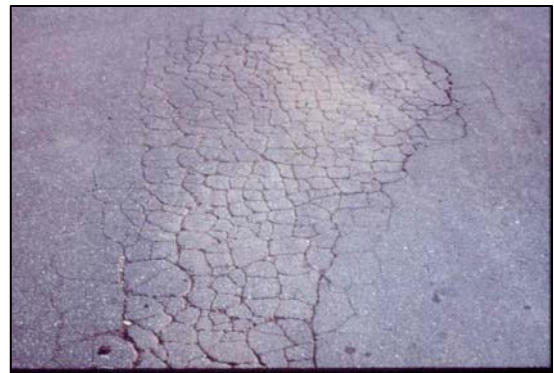
ALLIGATOR CRACKING: Interconnected cracks forming a series of small polygons, the pattern resembles an alligator's skin. It is caused by excessive deflection of the surface over unstable pavement base or subgrade layers that leads to fatigue failure. The unstable support usually is the result of saturated layer or layers or an unstable pavement design. It requires deep patching with HMA.

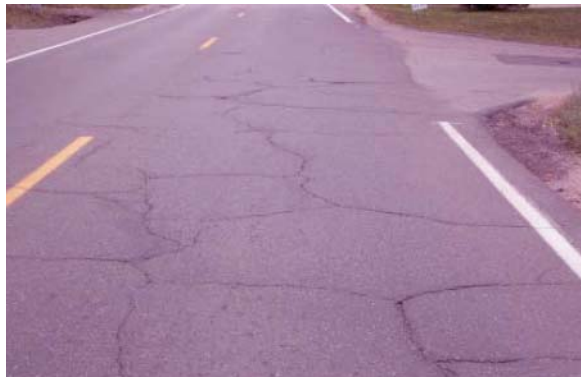
SHRINKAGE CRACKS: Interconnected cracks forming a series of large polygons, usually having sharp angles at the corners. It is caused by volume change in the base or subgrade. It requires monitoring of the hairline cracks, crack sealing, or fog treatment with asphalt material possibly followed by a surface treatment over the entire surface. *Photo courtesy of MnDOT.*

It is caused by volume change in the base or subgrade. It requires monitoring of the hairline cracks, crack sealing, or fog treatment with asphalt material possibly followed by a surface treatment over the entire surface. *Photo courtesy of MnDOT.*

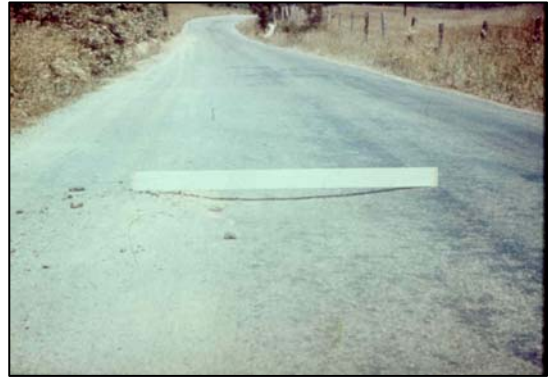
RUTTING: Longitudinal depressions that form under traffic in the wheel paths and have a minimum length of at least 20 ft. It is caused by consolidation or lateral movement under traffic in one or more of the underlying courses, or by displacement in the surface layer itself. Ruts should be filled with HMA (tight-blade) to restore proper cross-section. This should be followed by a thin overlay of HMA. *Photo courtesy of Asphalt Institute.*

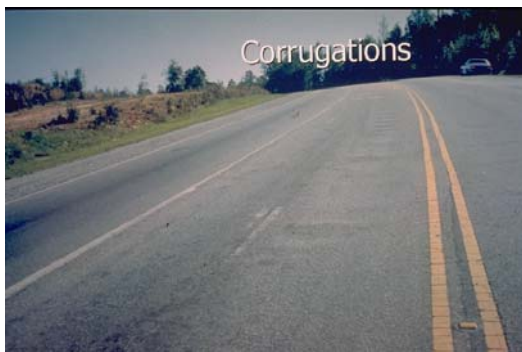
CORRUGATIONS: Transverse undulations at regular intervals in the surface of the pavement consisting of alternate, closely-spaced valleys and crests. It is caused by a lack of stability in the surface layers and requires repair before resurfacing. If the corrugated pavement has an aggregate base with a thick surfaced treatment, a satisfactory corrective measure is to mill off the surface, and replace with HMA. If the pavement has more than three inches (3") of HMA, shallow corrugations can be removed with a pavement milling machine, better known as "cold milling." This can be followed with a surface treatment or HMA overlay. *Photo courtesy of the US DOT and NCAT.*

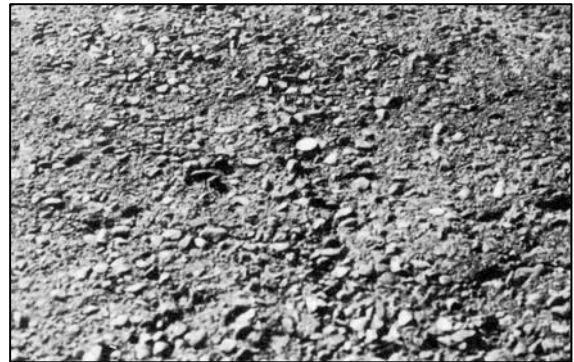
RAVELING: The progressive disintegration from the surface downward, or edges inward by the dislodgement of aggregate particles. It is caused by the original mix type, compaction capability during construction, construction during wet or cold weather, or overheating of the asphalt mix. It usually requires a surface treatment of some type. *Photo courtesy of LRRB.*

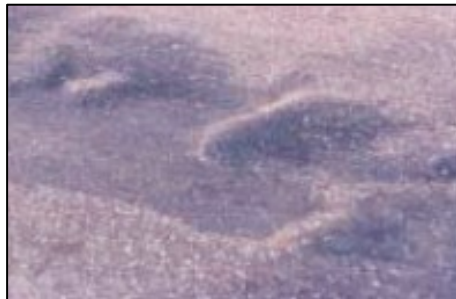
SHOVING: Lateral displacement of paving material due to traffic, generally resulting in the bulging of the surface. It is caused by lack of stability in the subgrade, base, or surface layers. It requires the removal of the affected area followed by deep patching with HMA. *Photo courtesy of FHWA.*

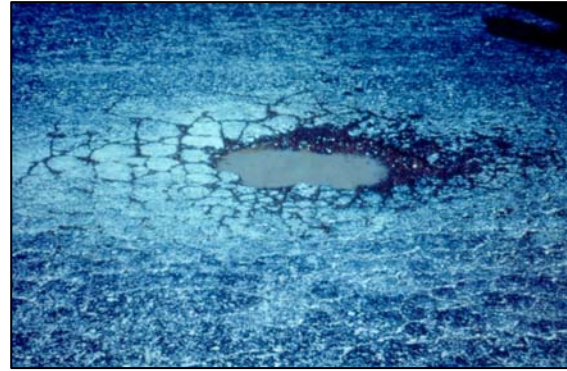
POT HOLES: Bowl-shaped holes of varying sizes in the pavement, often resulting from the progressive deterioration of other distresses such as alligator cracking. It usually is caused by a combination of weaknesses in the pavement for the given traffic resulting from insufficient HMA surface thickness, too many or too few fines, and/or poor drainage. It requires removal of the affected area followed by deep patching with HMA.

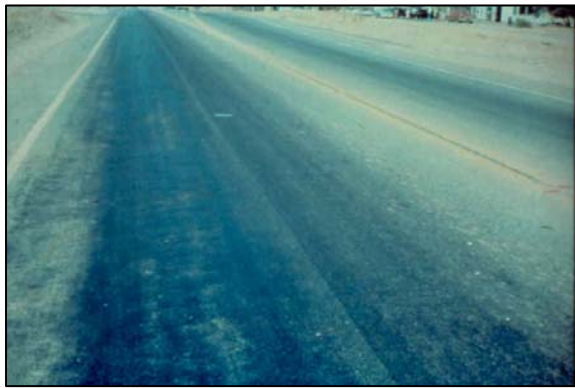
EXCESS ASPHALT/BINDER (BLEEDING): Free asphalt/binder on the surface of the pavement.

It is caused by too much asphalt/binder in one or more of the surface layers. In many cases, bleeding can be corrected by repeated applications of hot sand, hot screenings, or hot rock screenings to blot up the excess asphalt/binder. Sometimes, when bleeding is light, a plant mixed surface treatment or an aggregate seal coat using absorptive aggregate is the only treatment needed. In rare instances of heavily over-asphalted surfaces, the surface should be completely removed and replaced with HMA.

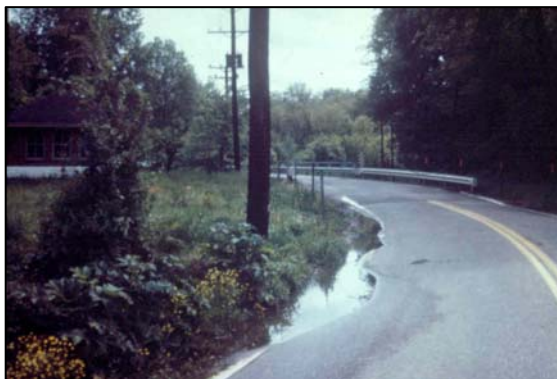
DEFICIENT DRAINAGE: Drainage problems may be considered in two categories: surface and subsurface. Proper surface drainage efficiently removes runoff from the pavement and the nearby ground.

Standing water on the pavement or in the side ditches indicates a drainage deficiency. Proper subsurface drainage keeps groundwater from the pavement structure. Two indicators of deficient subsurface drainage are 1) constant water in the side ditch, possibly with cat tails growing, and in the absence of precipitation, or 2) alligator cracking with moisture in the cracks.
